P.R.A. SAFETY COMMUNIQUE 2013-01

On May 12, 2013 a Monarch gyroplane experienced a pitch pivot bolt failure.

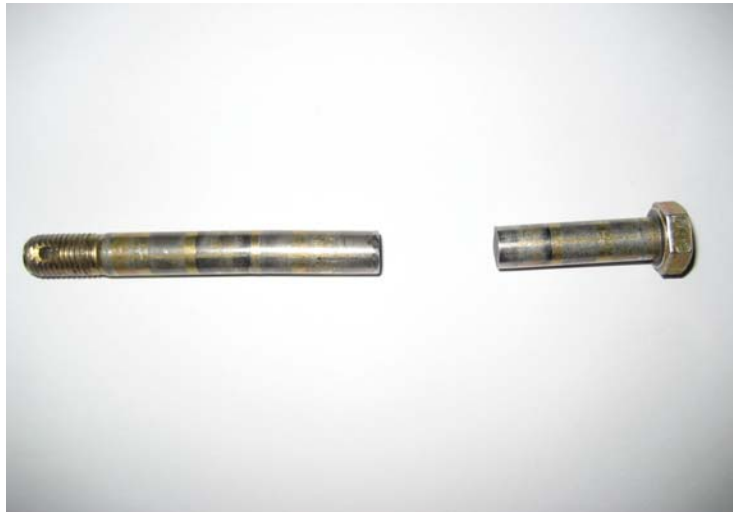
Inspection of the machine revealed two damaged propeller blades and a bent keel tube. Further investigation revealed the pitch pivot bolt, AN6-40, had separated at approximately one third of the grip length from the head of the bolt.

The cause of the bolt failure has not been determined; however, P.R.A. recommends that gyroplane owners/operators inspect the pitch and/or roll pivot bolts for discoloration around the pitch pivot bolt head and nut during each preflight for signs of unusual powder. If found you should, before further flight, remove the bolt and inspect its condition. Elongation, cracking, circular markings, etc. If any defect is found please replace the bolt with a known serviceable or new bolt and install in accordance with the manufacturers instructions.

It is also suggested that during normal maintenance, fifty hour, one hundred hour or annual conditional inspections that a torque wrench be used to verify that when the correct torque is applied that the bolt will not rotate in the hole. If the bolt does rotate, remove the bolt and check its condition. Replace as necessary.
